INTERMEDIATE AIR RECEIVER FRACTURE

An apparently standard air vessel burst and tore from its mounting. This case describes circumstances of use of this pressure vessel, and some investigations on the possible causes of failure.

INTERMEDIATE AIR RECEIVER FRACTURE - PART A

An investigation into a potentially fatal accident, traced to its probable causes by the author, W. Ernst Eder, The University of Calgary.

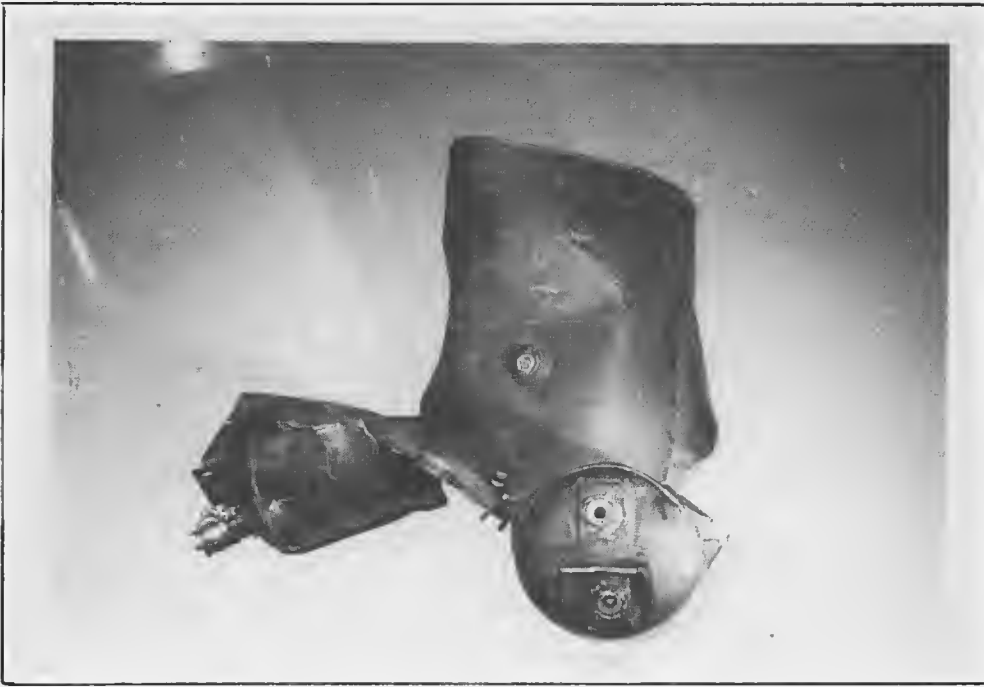
fig. 1 - Fractured Air Receiver, outer surface of body.

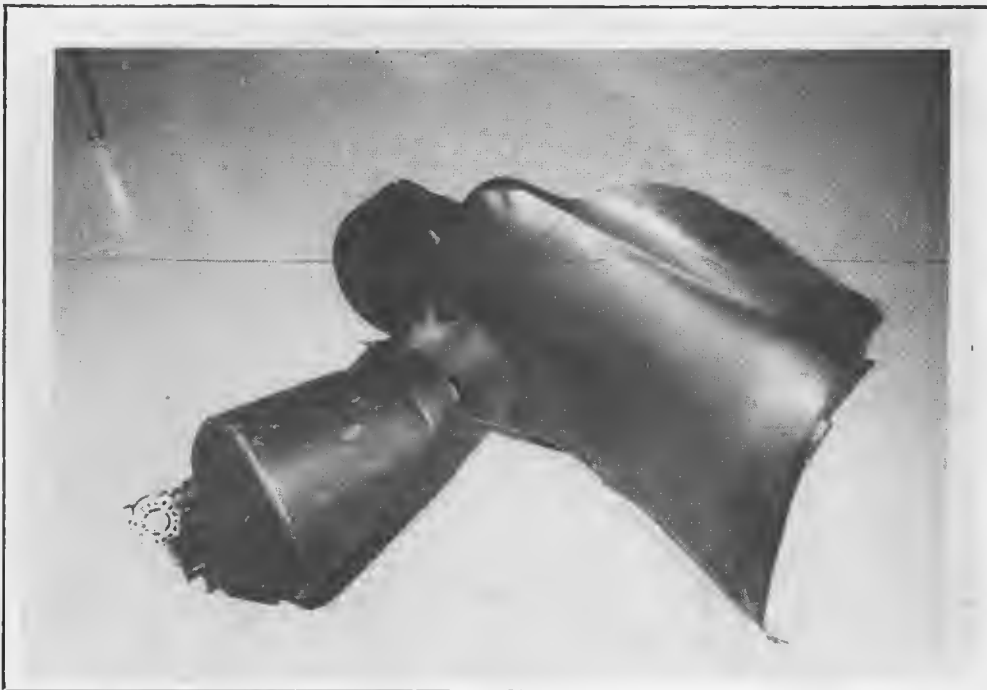
fig. 2 - Fractured Air Receiver, inner surface of body.

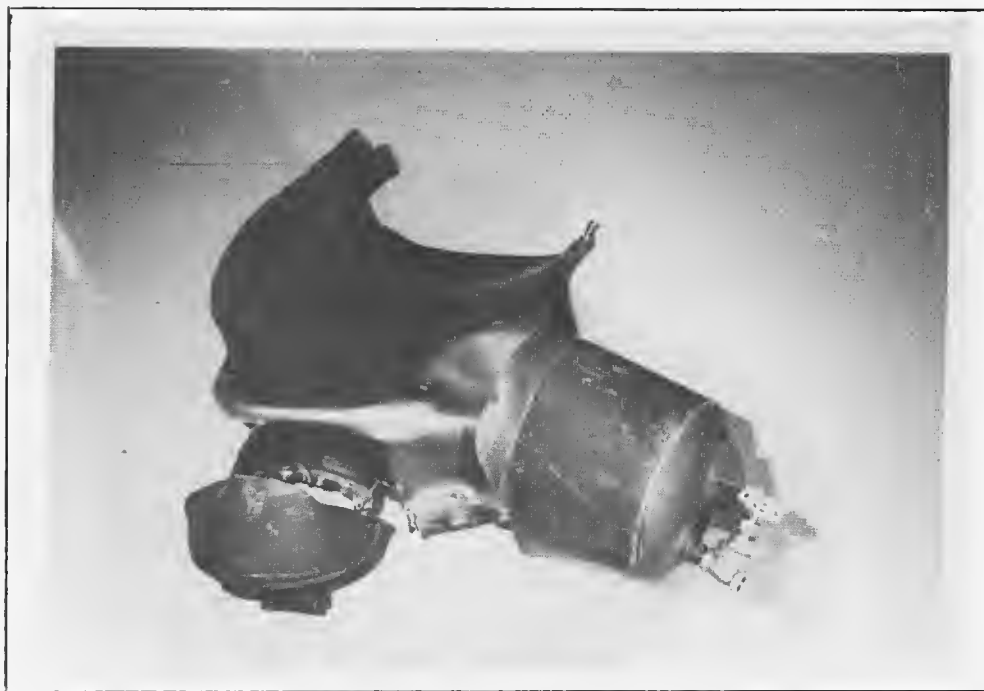
fig. 3 - Fractured Air Receiver.

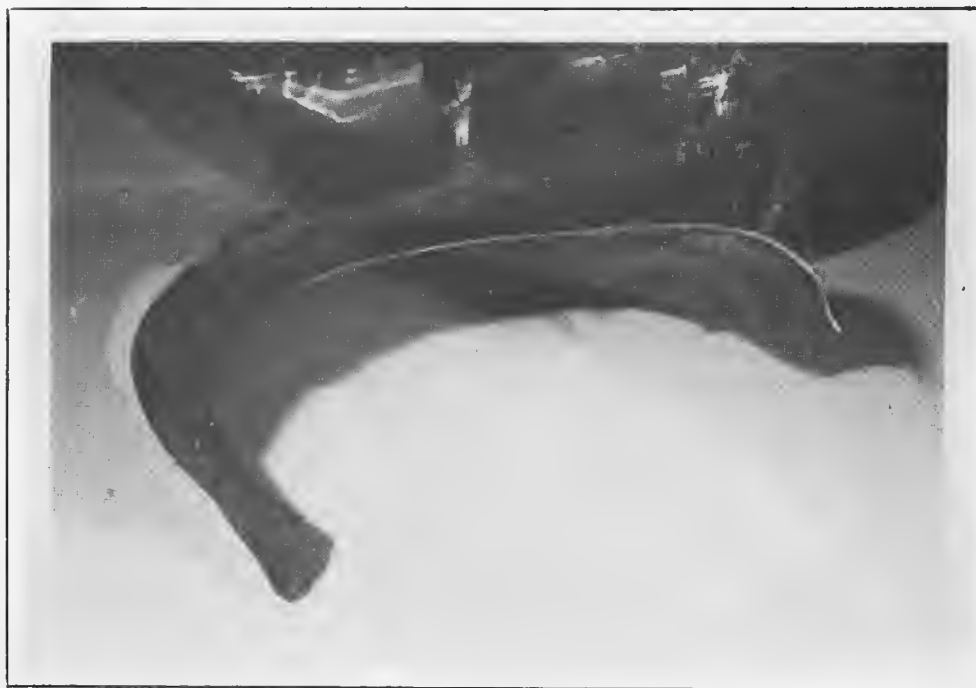
The rupture followed the line of the longitudinal weld seam, and turned close to the head seams at both ends, see figs. 4, 5 and 6, and exhibit 2. Features of the rupture surface I noted at this point were: a sharp, feathered edge with some thinning reaching back about 1.5 mm (1/16 in.) into the parent metal (see fig. 7); the weld metal was adjacent to the rupture on one side or the other for most of its length; some areas of incomplete penetration of the weld were obvious (see figs. 8 and 9), leaving about half of the thickness of the parent metal visible for about 250 mm (10 in.) of the total vessel length of 610 mm (24 in.); a circumferential rupture progressed at about 150 mm (6 in.) from one end, and reaching around three quarters of the circumference.

fig. 4 - Edge of fracture along Longitudinal Weld Seam.

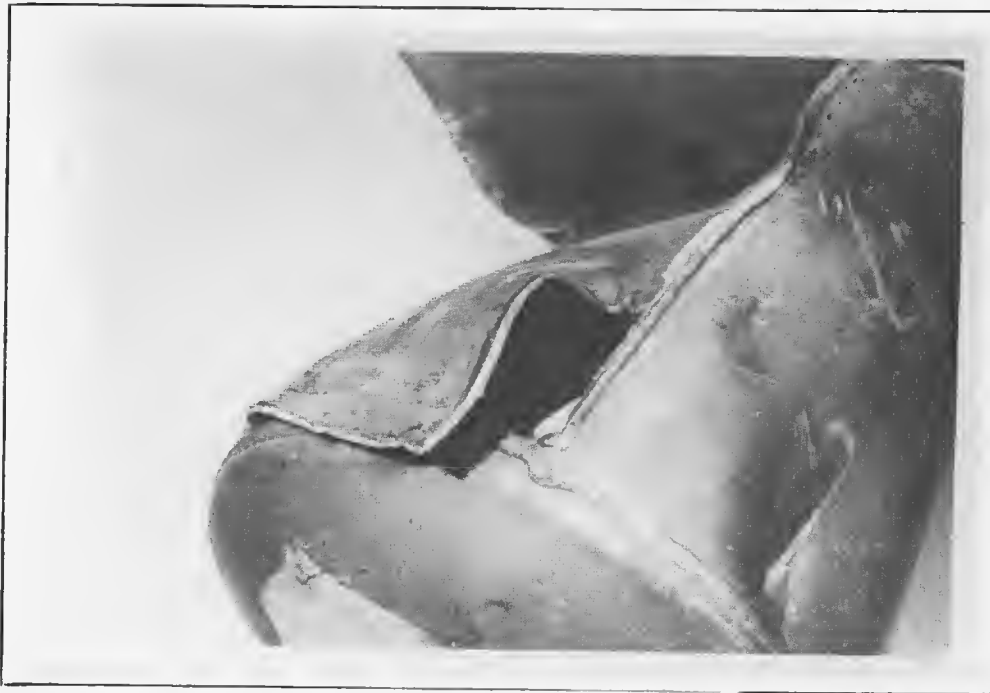
fig. 5 - Fracture at Unmodified Head.

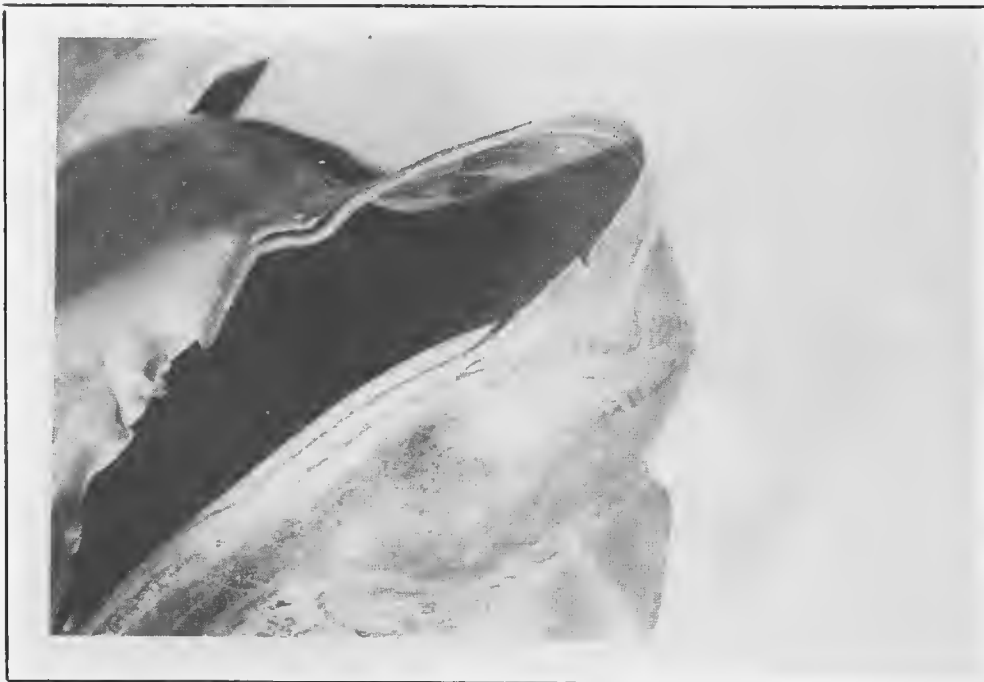
fig. 6 - Fracture at Modified Head.

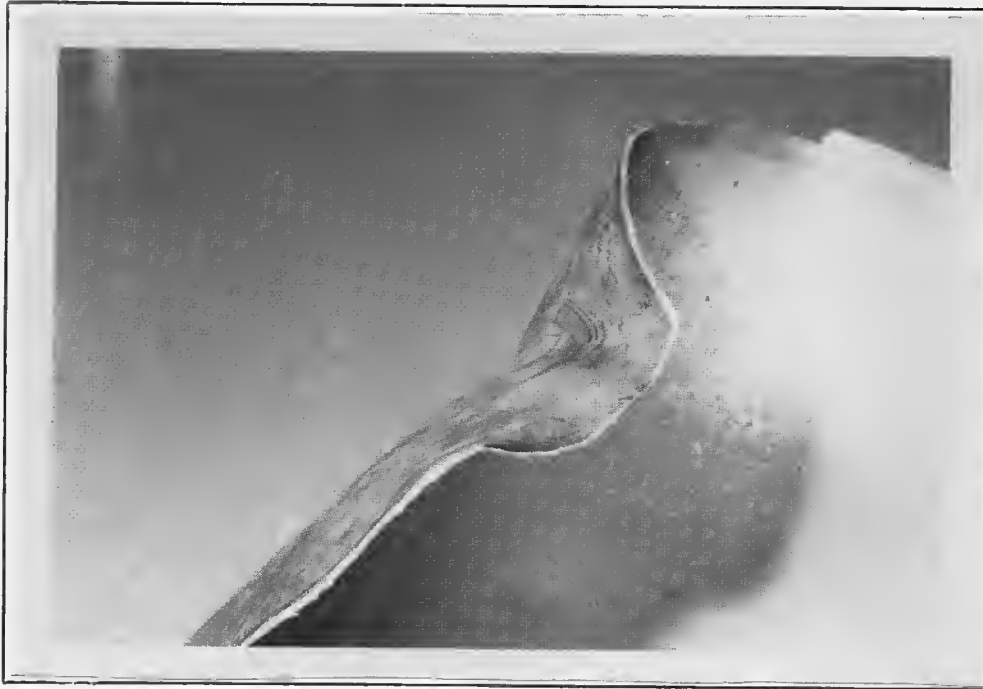
fig. 7 - Body Plate at Modified Head; note the deformed shape as fracture changes direction.

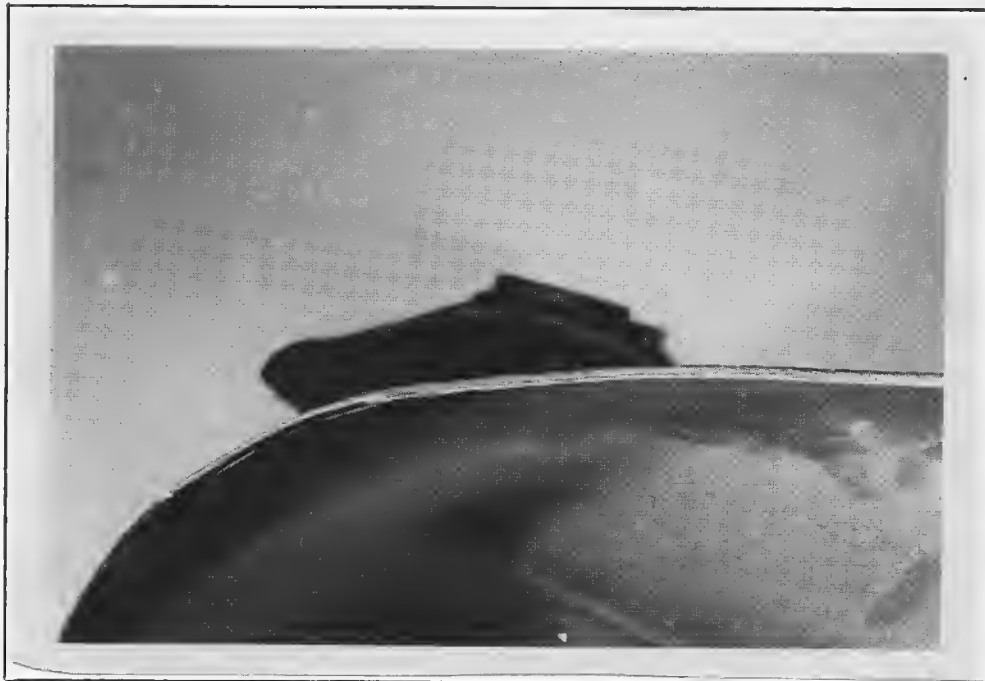
fig. 8 - Longitudinal Seam; note fracture in the heat-affected zone along most of the weld, and lack of weld penetration along inner edge.

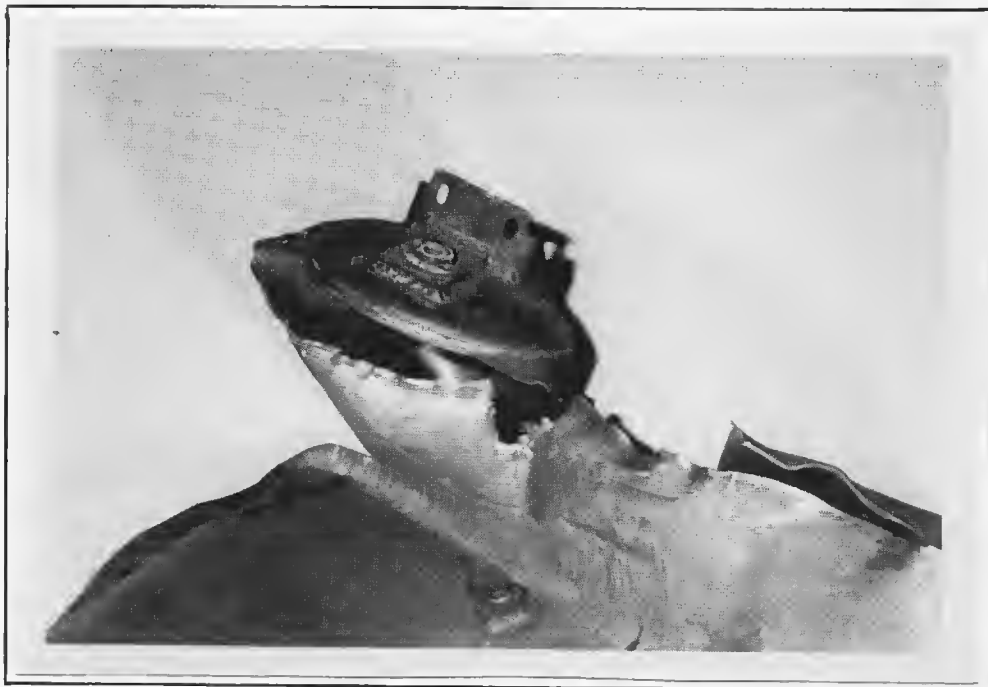
As a result of the rupture, the receiver was torn from its mounting, and propelled rocket-like against a structural member or service pipe, causing the scuff marks near an entry plug, figs. 10, 11 and 12. The mounting bolts were apparently not found, and were not available to me.

fig. 10 - Scuff Marks from Impact.

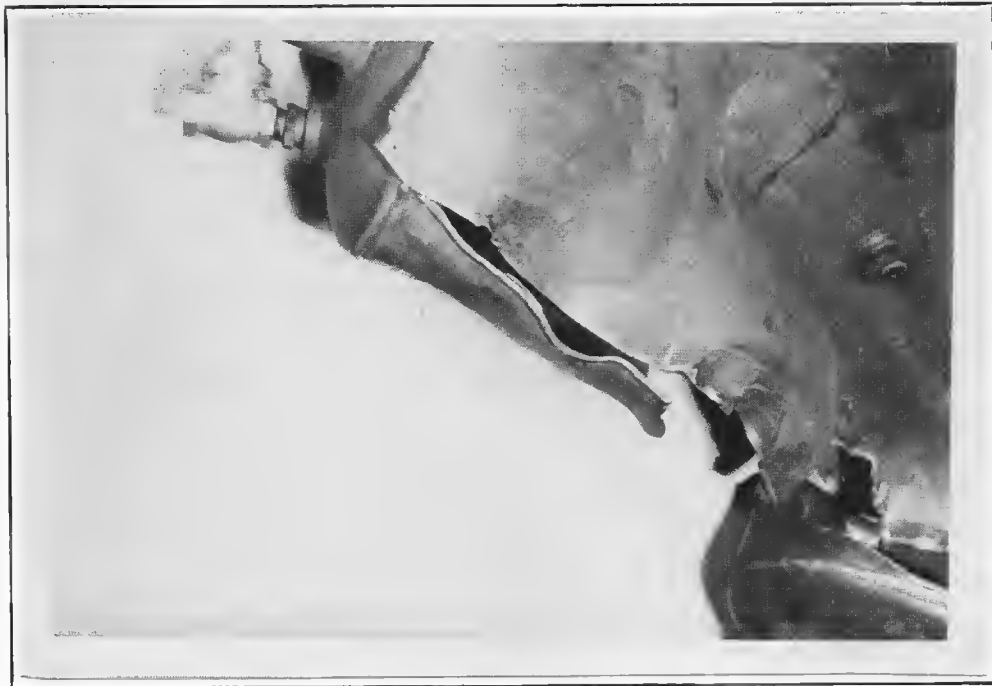
fig. 11 - Deformation due to Impact.

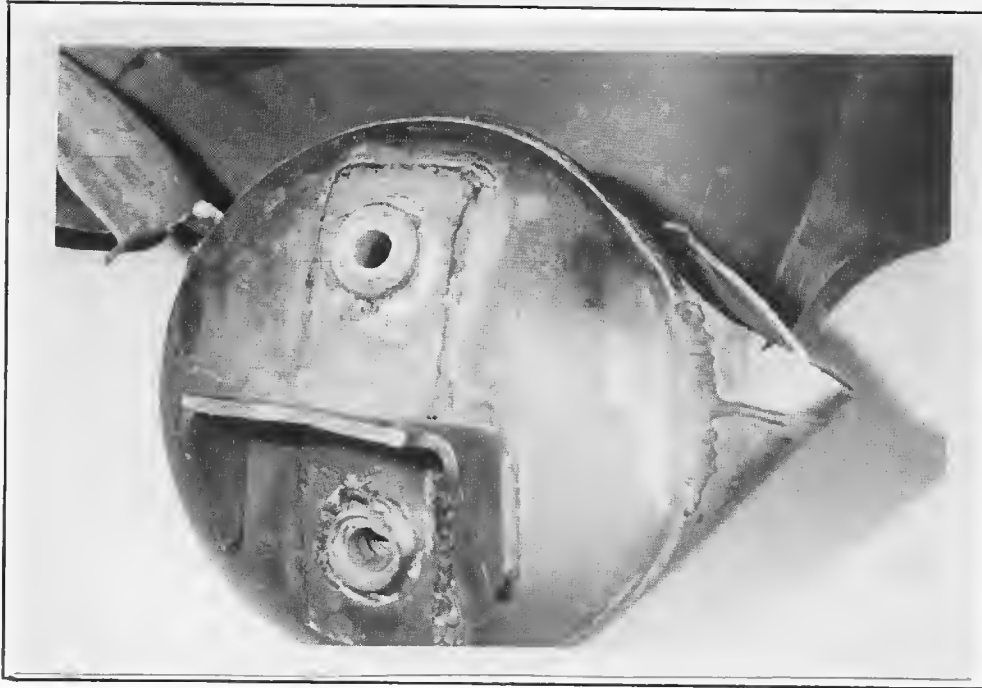
The opposite end of the receiver contained two entries (see figs. 13 and 14). One was a boss with a single brass screwed pipe end, which had fractured at the entry in the root of a male thread. The second was a tube entering the vessel, with two steel screwed pipe ends, one entering from inside the vessel, the other from outside, both showing fractures at the entry points. The areas around these entries had been reinforced by welded plates, the welds having been made by electric arc hand welding. Slag was not cleaned off, weld spatter appeared on the parent metal and on the reinforcements, and the corrosion protection paint on the inside surface of the vessel had been burned off. The head seams on the air receiver, close to the longitudinal seam of the body, had been repair-welded, leaving an unpainted area visible on the inside (see figs. 6 and 13).

fig. 13 - Modified Head, outside view.

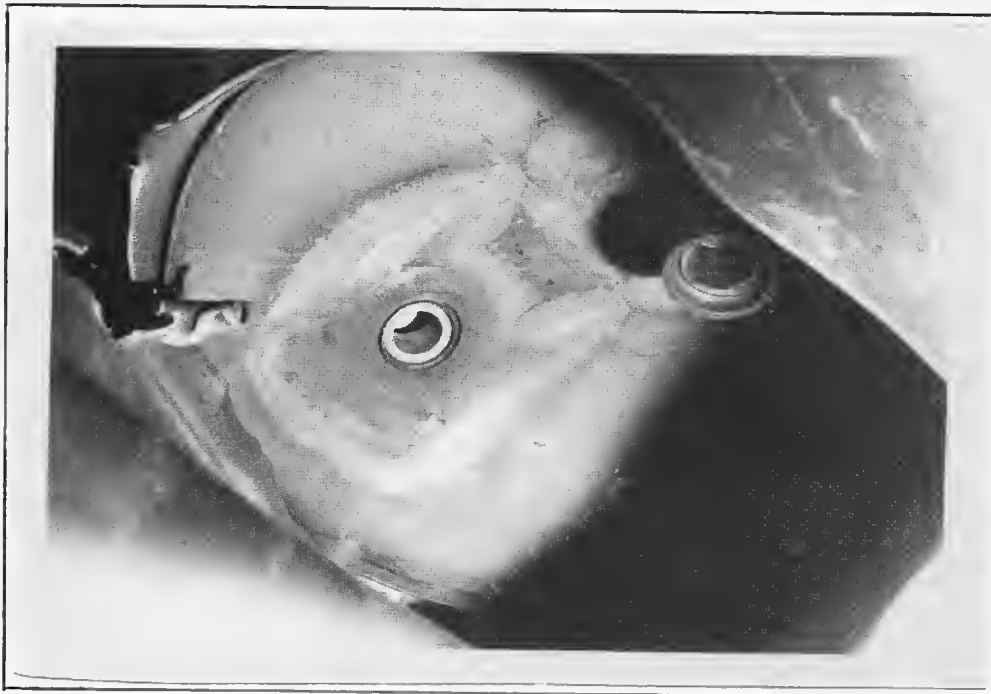
fig. 14 - Modified Head, inside view.

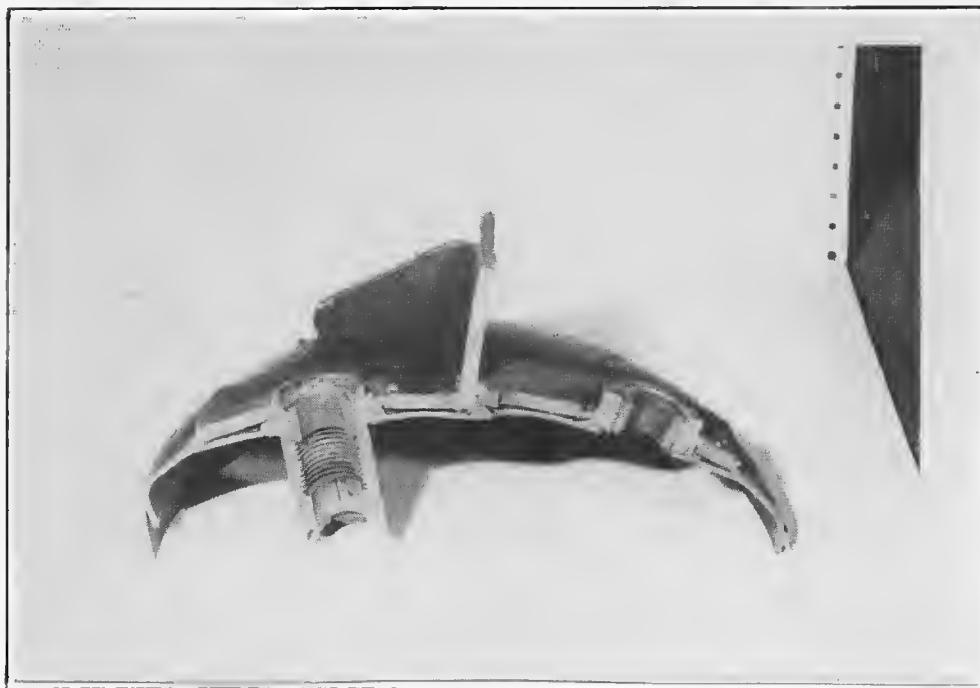
The modified head of the intermediate air receiver was cut along the center of the two entries, see figs. 15, 16 and 17. One half of this head was filed flat, and macro-etched in a 10% HNO_3 (Nitric acid in water) solution for 30 minutes, to reveal the major boundaries of weld-metal and other discontinuities. The short boss containing the brass screwed pipe end looked as if it was probably original equipment, a good weld was revealed around the outer edge.

fig. 15 - Modified Head, section prepared for macro-etching.

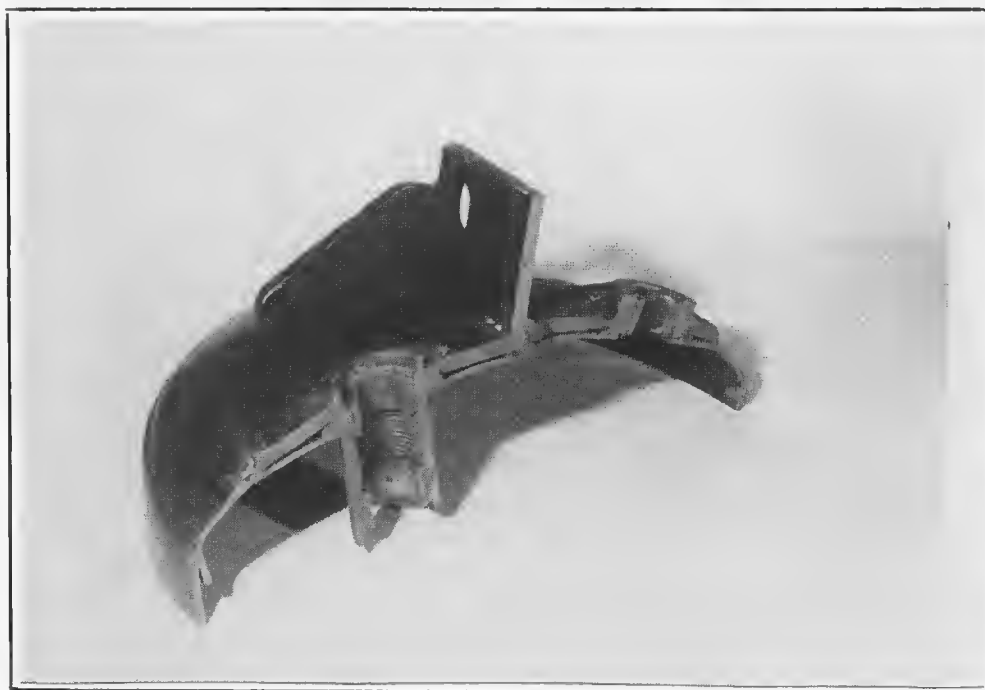
fig. 16 - Modified Head, section.

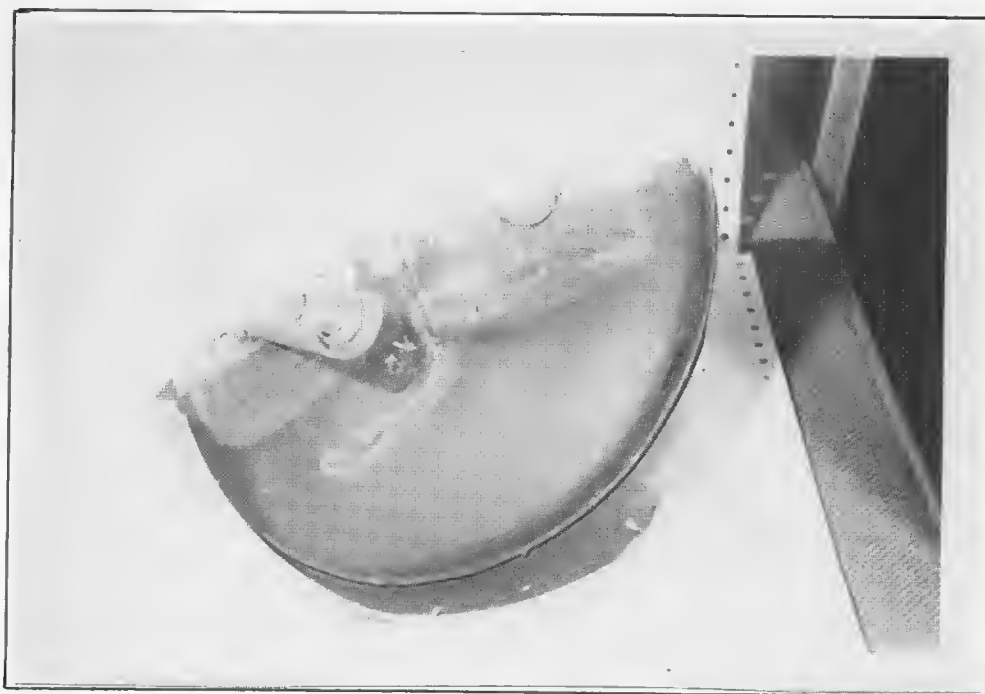
fig. 17 - Modified Head, inner surface.

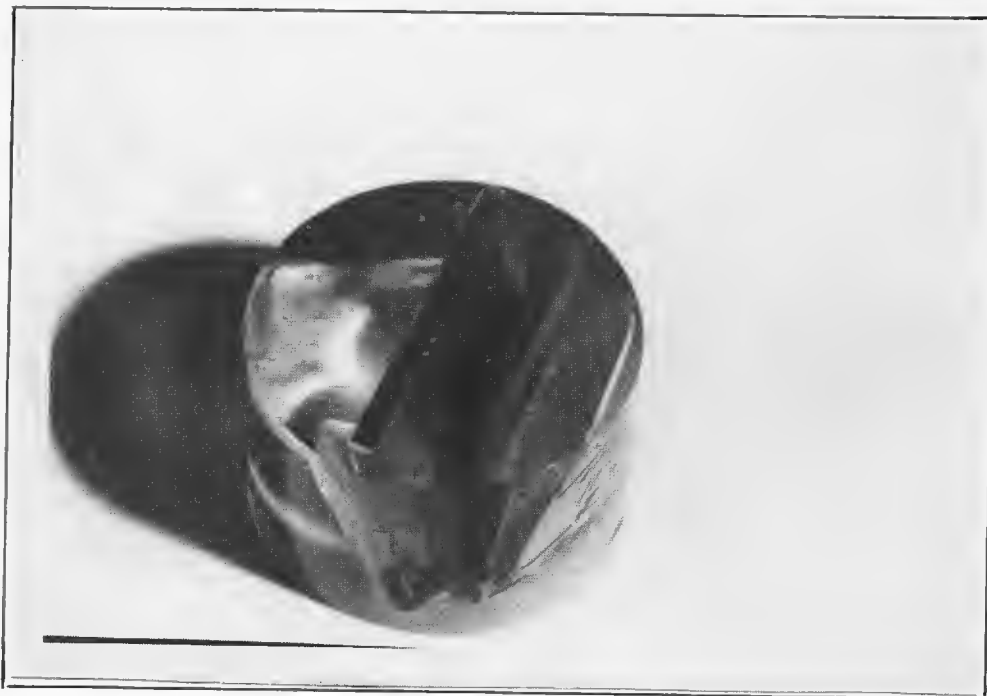
Sample 1 (fig. 20) was taken from about the middle of the vessel, at the free edge of the rupture (see exhibit 3). It shows the 45° slope of the rupture surface and the thinning behind it. The grain structure under microscopic observation shows a distinct stretching of individual grains as the fracture surface is approached. Failure was in a shear mode, typical of a ductile fracture under relatively low rate of stress application, with little constraint by stress concentration effects.

fig. 20 - Fracture Edge; note thinning (on right-hand sample towards front) and slope of fracture edge.

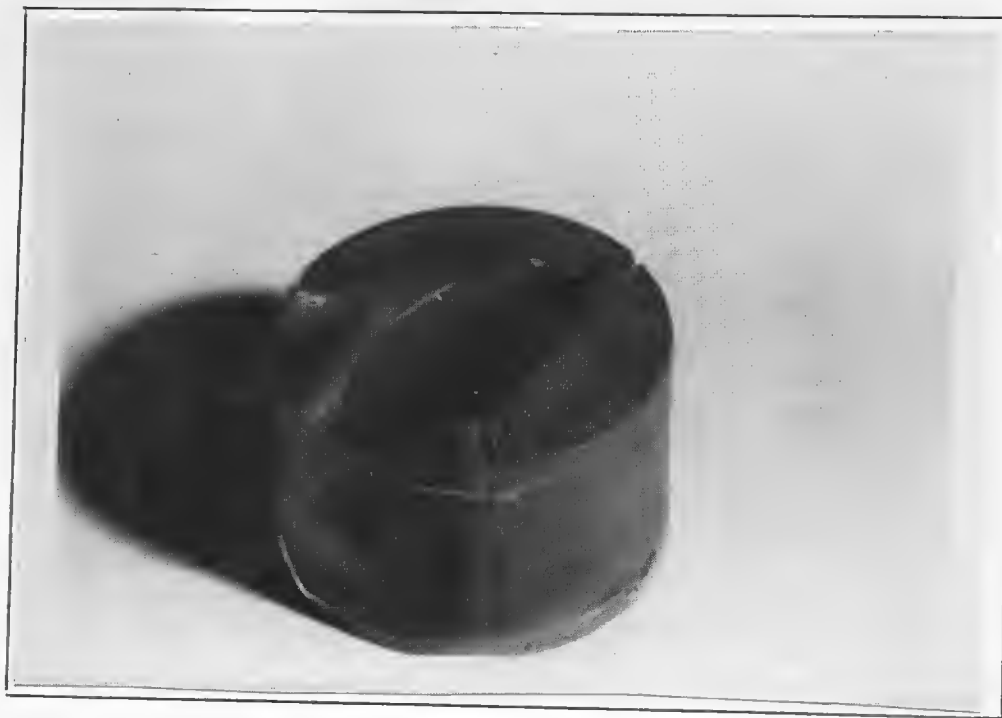
Sample 2 (fig. 21) shows the fracture leading from the longitudinal weld. The step resulting from incomplete penetration of the weld at this point can be clearly seen. The fracture surface is along the

heat affected zone of the weld region, starting almost parallel to the parent metal surface, and curving outwards to that surface. The weld shows a coarser, dendritic structure, as would be expected from a good weld that had not received an annealing or normalizing heat treatment.

fig. 21 - Longitudinal Weld Seam, incomplete penetration;
note step at front of right-hand sample, opposite
the raised weld bead.

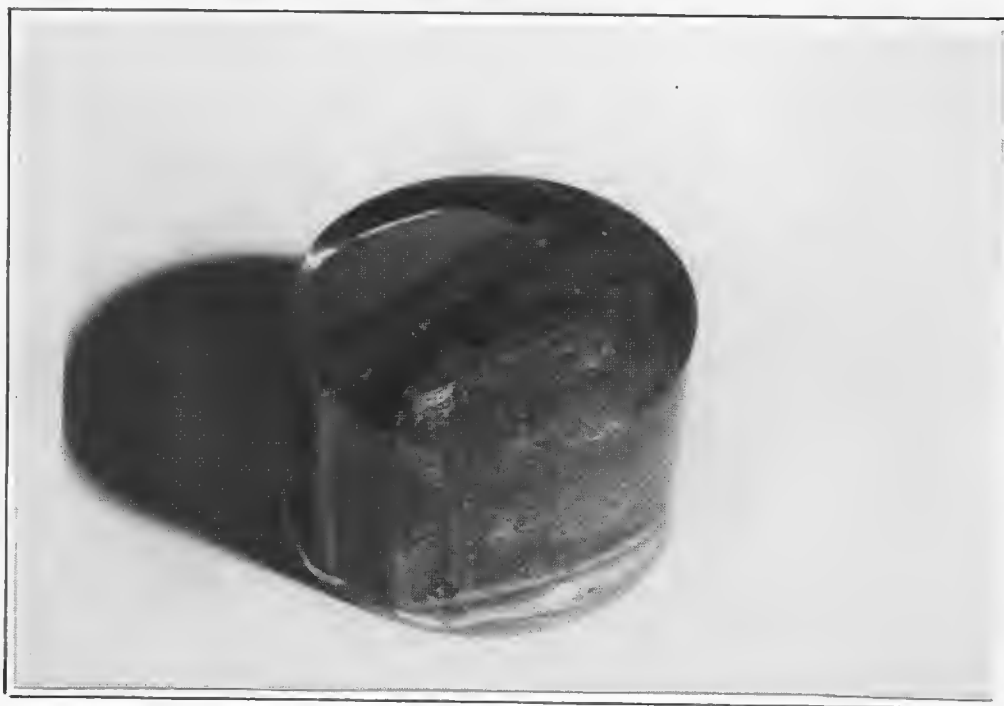
Sample 3 (fig. 22) was taken from the longitudinal weld at a point of good weld penetration. The fracture here is remote from the weld, and shows similar stretching to sample 1.

fig. 22 - Longitudinal Weld, complete penetration; fracture
in parent metal, thinned by stretching as in fig. 20.

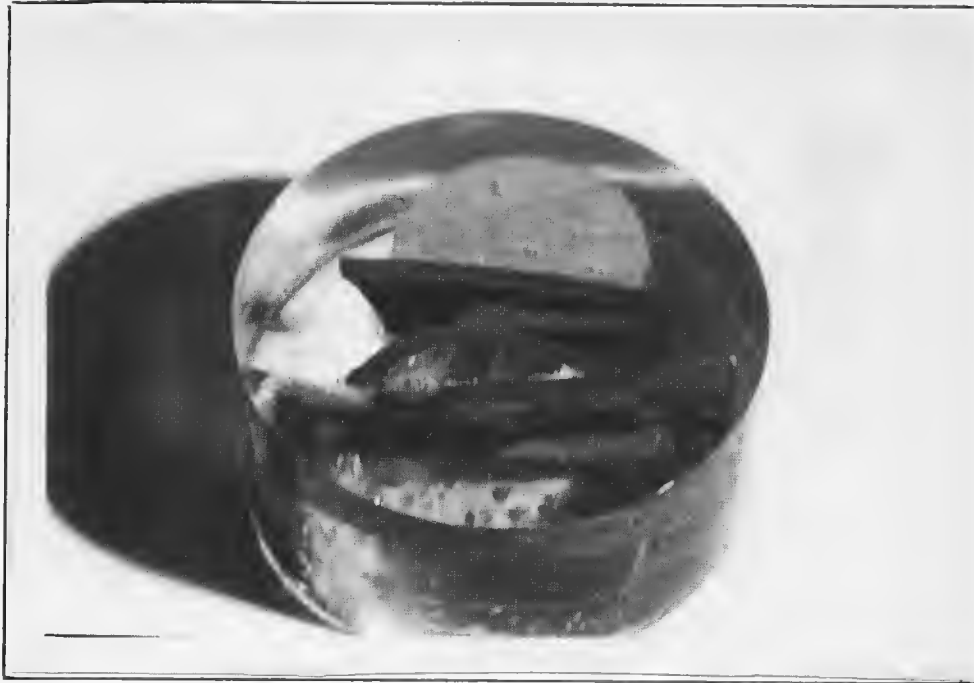
Sample 4 (fig. 23) shows the machine-welded section of the head-to-body weld at the modified head. The weld is good, with adequate melting into the parent metal of the head. Sample 5 (fig. 24) is taken from the repaired portion of the head weld. It reveals that the initial weld was made over a fairly large gap, probably about 0.5 mm (0.020 in.), the overlaid hand weld is of coarse grain structure, with somewhat irregular dendrite distribution. This weld could be classed as of medium quality; I suspect that it was a repair weld made by the vessel manufacturer when a leak was detected under test.

fig. 23 - Head Weld Seam, original weld metal (middle sample),
head to left, body to upper right.

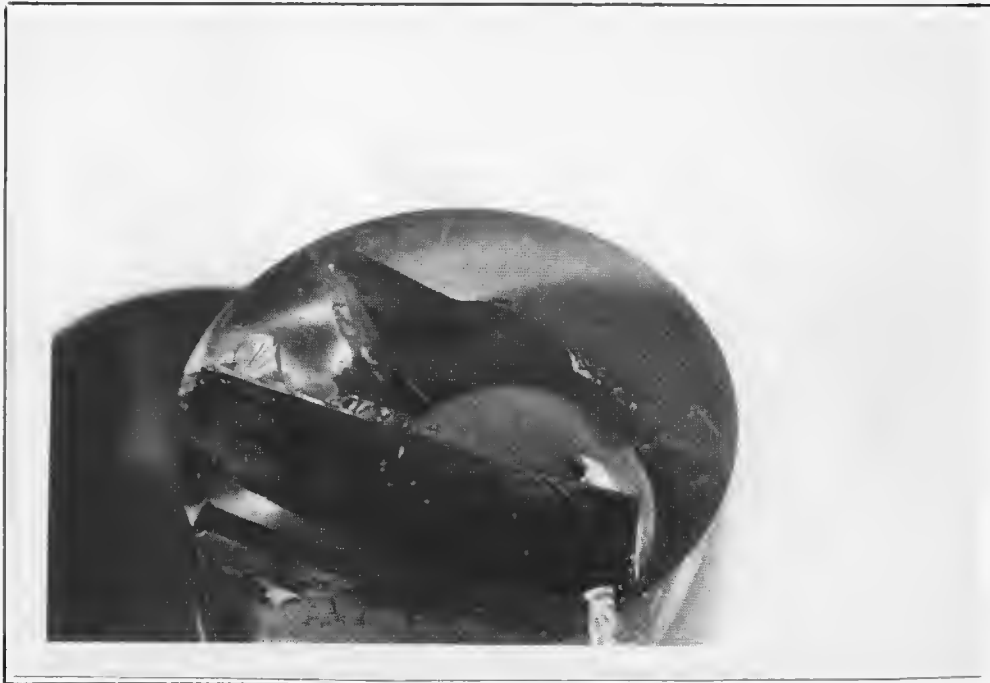
fig. 24 - Head Weld Seam, repair weld by hand (top sample),
head to right, body to upper left.
